Accident Review Spring 2014

Truckee, California • BY DICK ROCHFORT

NTSB Identification: WPR14FA127
14 CFR Part 91: General Aviation
Accident occurred Monday, March 03, 2014,
 in Truckee, Calif.
Aircraft: PIPER PA-46 350P,
registration: N9281F
Injuries: One fatal, one serious.

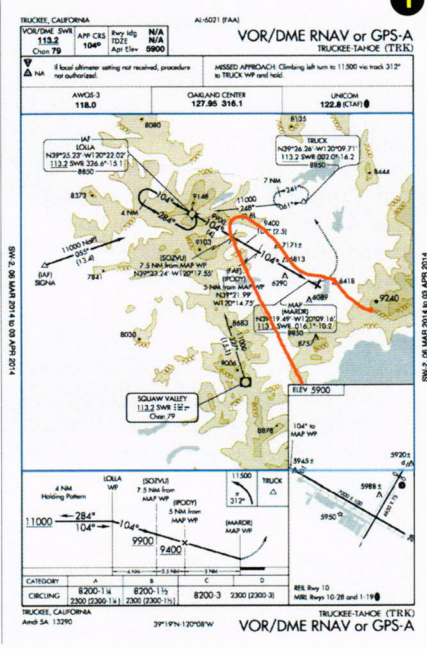
The red line in Figure 1 represents the Flight Aware radar track superimposed over the GPS-A at Truckee Airport. As of this writing, we don't know what clearance was received, and the track is only an approximation, but it suggests that a non-standard procedure turn was flown and that the missed approach was not flown in a timely manner or in the correct direction.

Staying on the thick black line of the procedure is arguably the most important critical task. One common error which can cause confusion leading to this type of accident is a failure of the GPS to automatically sequence during the approach. This subtle but entirely predictable event can lead to a major loss of situational awareness and/or a serious distraction.

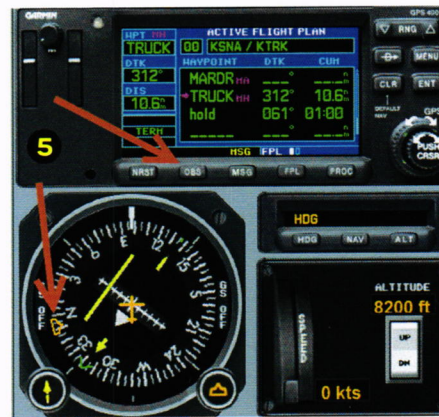
Figure 5 illustrates the guidance provided by Garmin after the OBS button is tapped to remove the SUSP annunciator.

"SUSP" (suspend in "Garminology") means that sequencing will not occur; therefore tapping the button will initiate a manual sequence. The remedy is be vigilant for the occurrence of a failure to sequence and to simply tap the OBS button to remove the "Suspend" feature or to reactivate the correct leg of the approach, using the time-honored "direct-direct-enter" sequence. If Garmin sees the
