National Transportation Safety Board Aviation Accident Final Report

Location:	Shreveport, LA	Accident Number:	CEN19FA088
Date & Time:	02/28/2019, 1040 CST	Registration:	N428CD
Aircraft:	Piper PA46	Aircraft Damage:	Substantial
Defining Event:	Loss of control in flight	Injuries:	2 Fatal
Flight Conducted Under:	Part 91: General Aviation - Personal

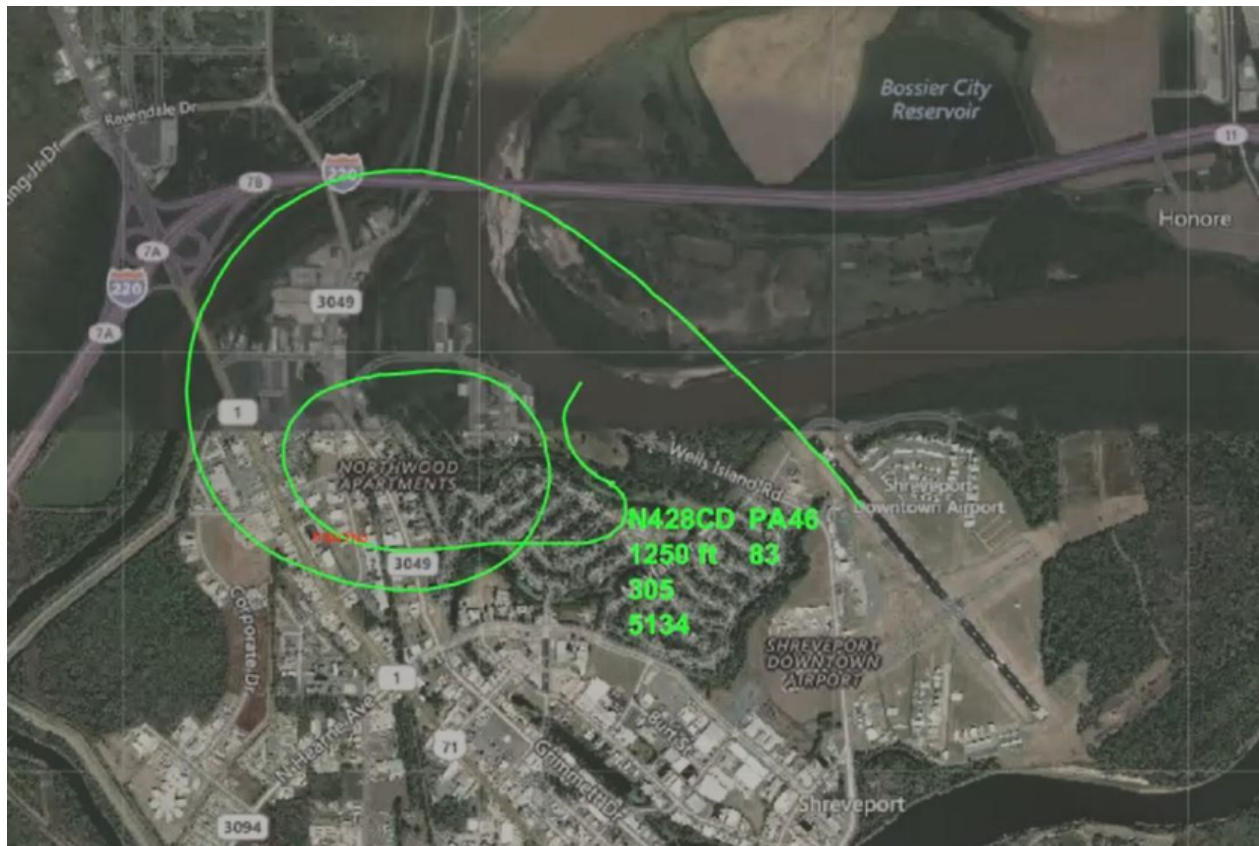
Figure 1 - Air Traffic Control Flight Track of N428CD

After climbing to 1,400 ft msl, the airplane's altitude and airspeed began to fluctuate as it continued in a tightening left spiral (see figure 1). About 35 seconds after transmitting "standby," the pilot stated, "we're in trouble up here." The airplane subsequently made a decelerating right turn then rapidly descended. The last ATC data recorded for the flight indicated a groundspeed of 31 knots at 575 ft msl.

Onboard data showed the airplane's altitude, vertical velocity, and speed oscillated several times and the turn rate increased during the last minute of the flight. From 10:39:25 to 10:39:58, the airplane's altitude varied from 1,987 to 822 to 1,980 ft msl and the vertical velocity fluctuated from -6,001 to +5,834 ft per minute (fpm). The last data captured at 10:40:07 was 1217 ft msl and -6818 fpm.
