Can inlet corrosion be stopped simply by washing?

Stop

by Abram Finkelstein

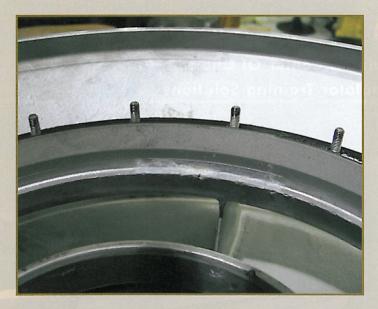
Top, corrosion on the inlet case is found in two spots at the 1 o'clock position. One is next to the studs on the interior and not visible. The 1 o'clock position in this photo is the 6 o'clock position when the engine is installed. Center, a closer view of the two spots. Bottom, corrosion found under the silicone inlet screen.

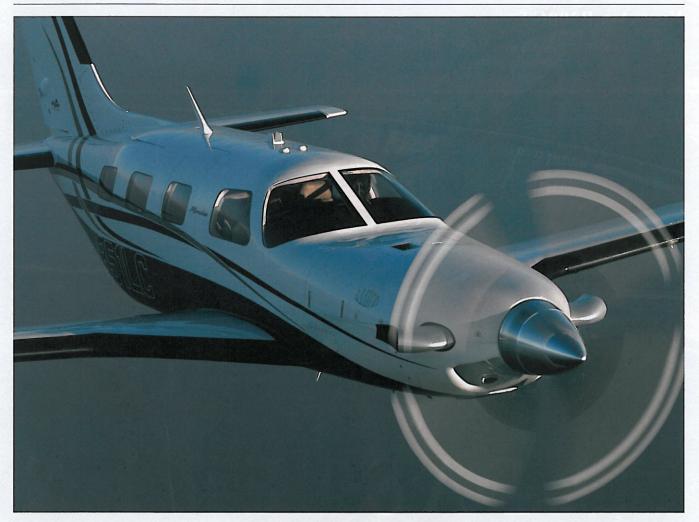
In a worst-case of engine inlet corrosion, the entire inlet would have to be replaced.
