## Alternate Air Door Issues

# SERVICE No. 961 BULLETIN

Alternate Air Door Replacement  
 and Control Linkage Inspection

Amendment 39-5558; AD **87-04-01**

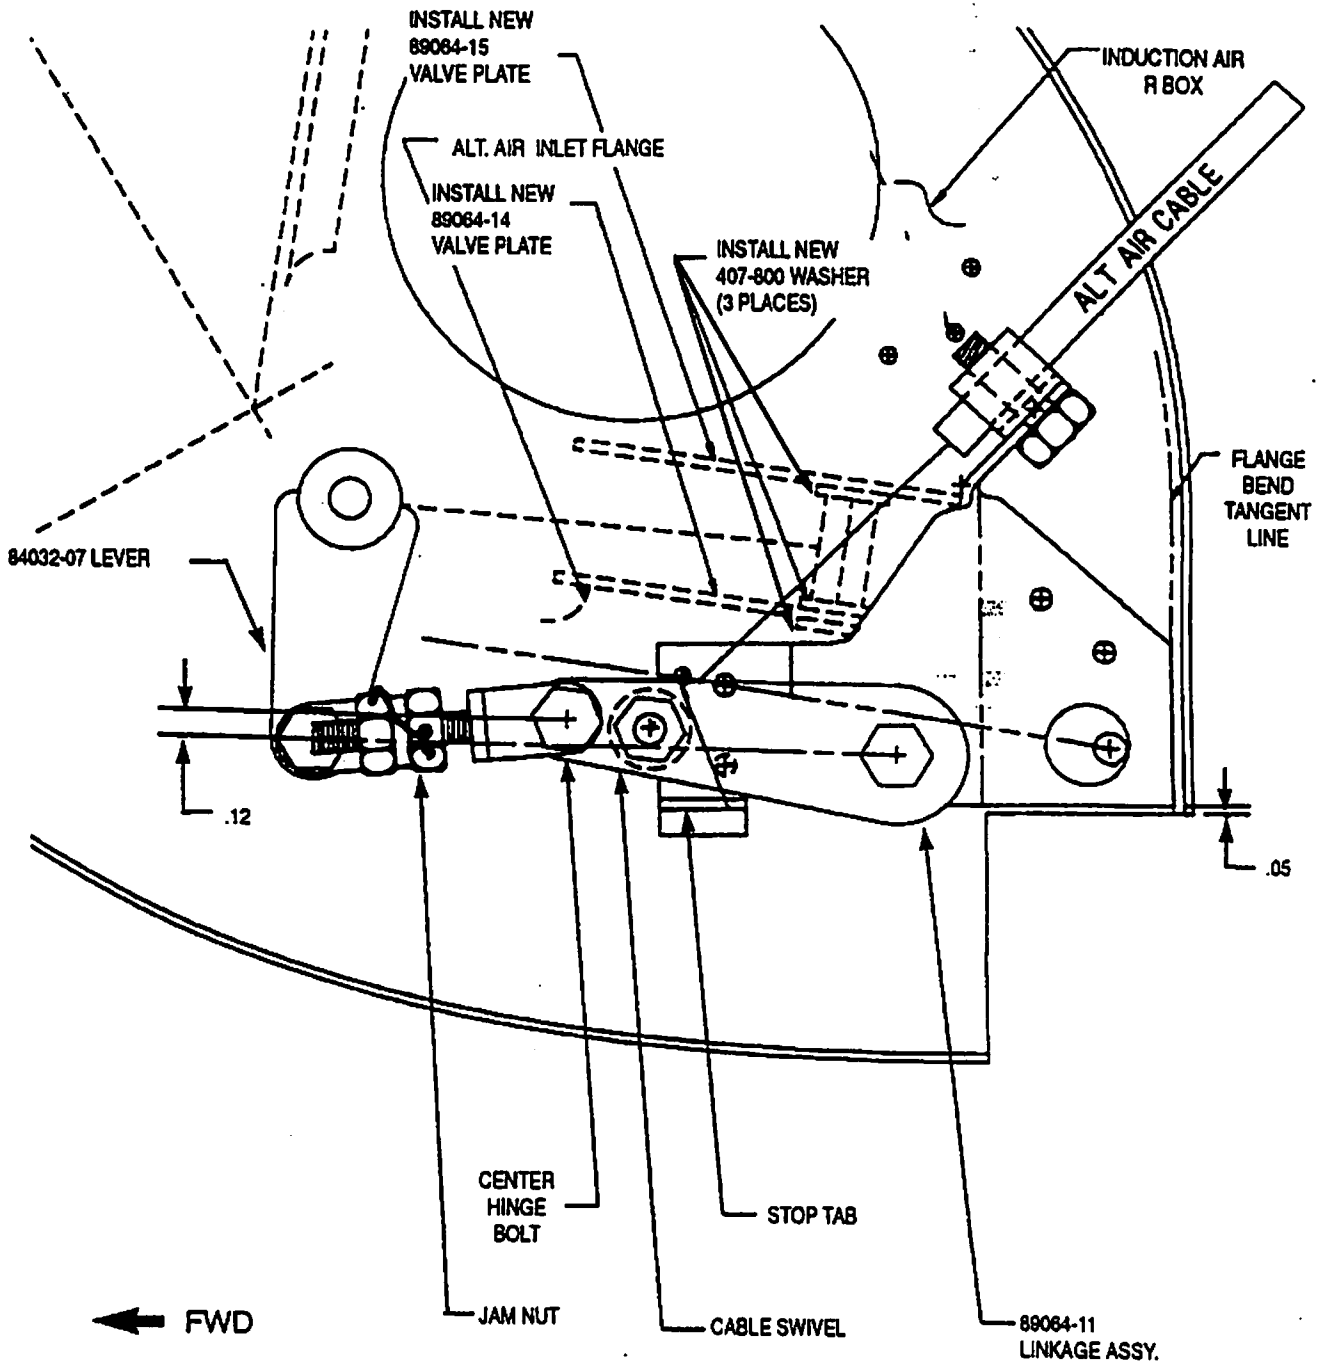
SKETCH A

Information from a recent Service Difficulty Report and subsequent follow up by Piper, indicate that the lower valve plate in the alternate air door assembly may crack and if not detected through normal inspection, could propagate until portions of the valve plate separate entirely. This may result in large pieces entering and possibly lodging in the induction air duct which could potentially result in a loss of engine power. Examination of these cracks indicate that they have occurred due to stress being placed on the valve plate when the control arm is improperly rigged.

3. Refer to Sketch A. Remove existing cable clamps and hardware. Remove existing swivel and retain hardware for re-use except discard cotter pin.
4. Remove existing alternate air valve plates and six (6) each P/N 404-564 washers. Retain only the bolts for re-use.

7. Make rigging adjustment as necessary. Assure lever meets stop tab when lever is  $.12 + .06/-0$  inch before center. This may be accomplished by making a measurement between the center of the P/N 89064-07 crank bolt and the bolt at the opposite end of the linkage and measuring up  $.12$ " to the center of the center hinge bolt. Make adjustments to jam nuts as required to seal the P/N 89064-14 valve plate. Localized gaps between valve and alternate air inlet flange are not to exceed  $.015$ ". When making this adjustment the linkage should rest on the stop with no pressure on the lower valve plate. In order to assure that no distortion is present, it will be necessary to remove the two induction air hoses located on either side of the air box. With a strong light observe the plate with the alternate air selected and deselected. There should not be any distortion in the plate when engaging the door. Tighten jam nuts and safety wire together. Use  $.032$  stainless steel wire.

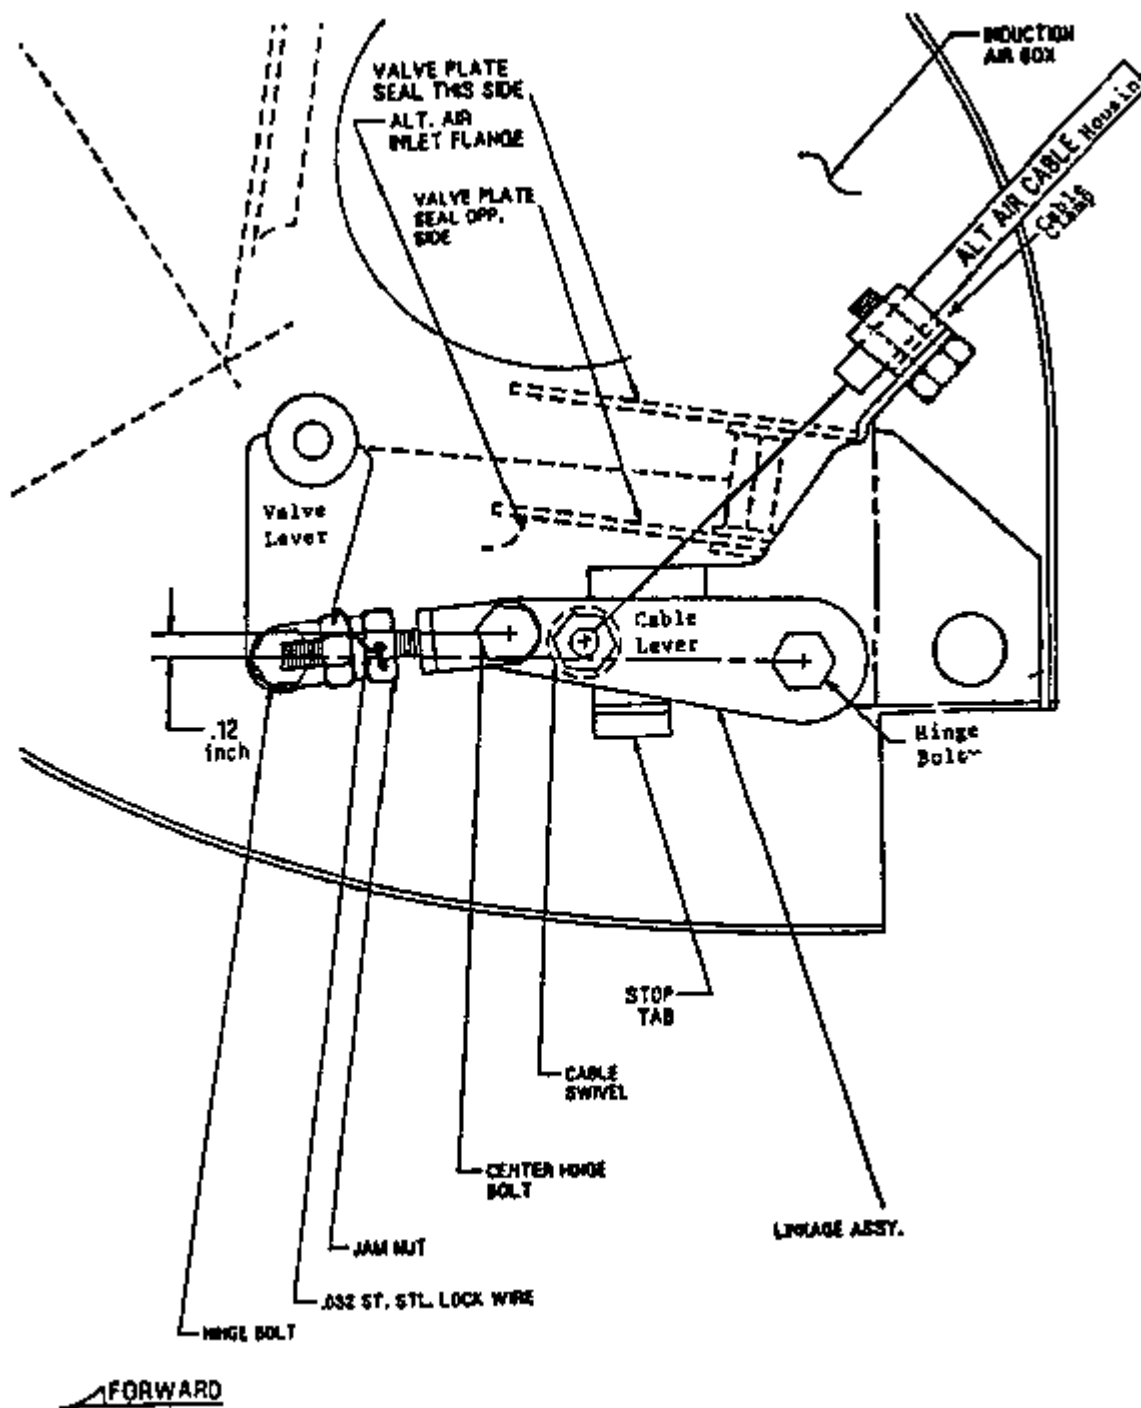
FIGURE 1

To prevent engine power loss, accomplish the following:

- (a) Remove the top and the lower left-hand engine cowl.
- (b) Determine whether or not the alternate air valve linkage shown in Figure 1. has been installed on the left side of the engine air box.

- (i) Position the alternate air control (located inside the cockpit) approximately mid-way between the primary and the alternate position.
    - (ii) Refer to Figure 1. and bend the stop tab so that the linkage is stopped 0.12 inch plus 0.060 minus 0.000 inch before center. This dimension is determined by measuring the perpendicular distance between a line through the centers of the cable lever and the valve lever hinge bolts and the center point of the center hinge bolt.

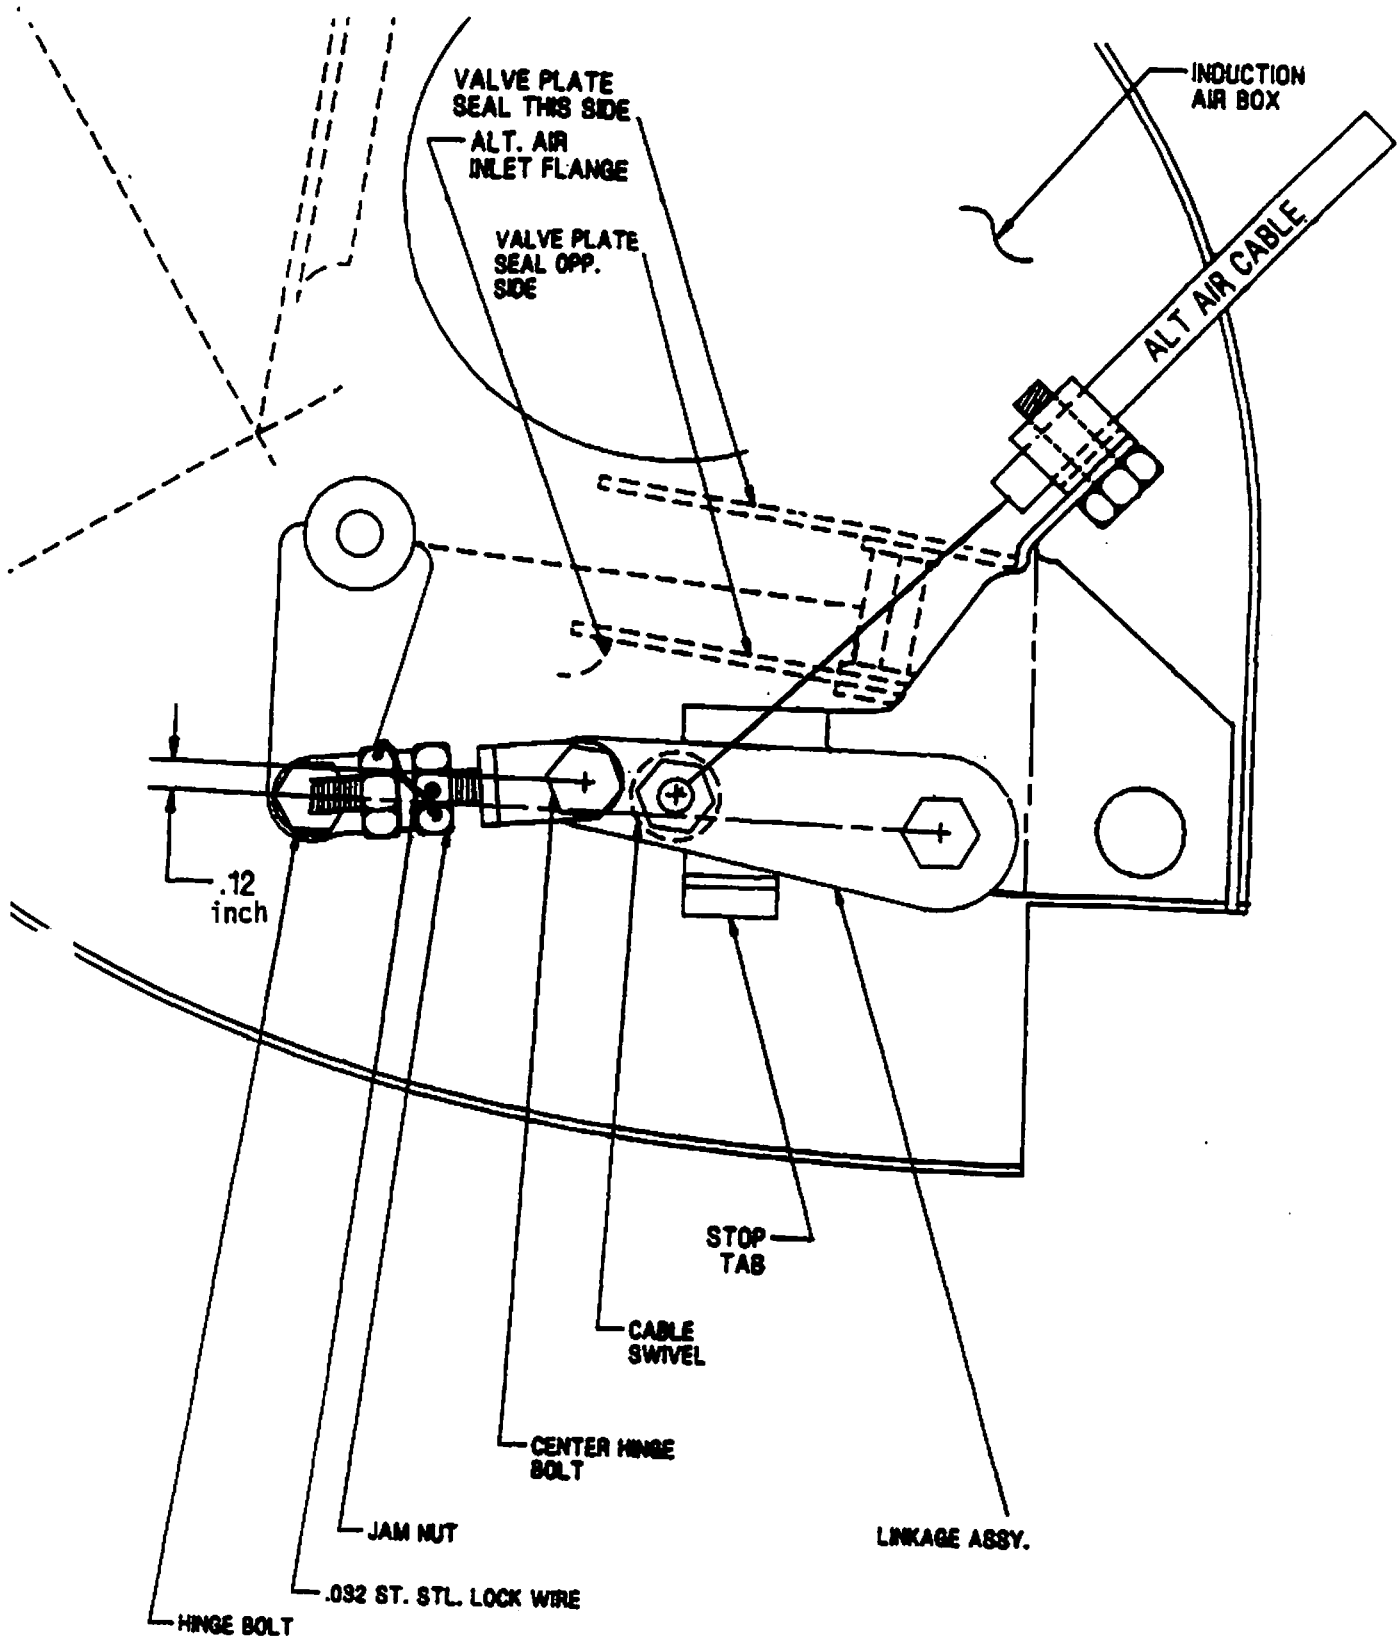
SKETCH "A"

PURPOSE: Engineering tests indicate that conditions may exist that would prevent selection of alternate induction air when the primary air source is cut off. Two (2) reports of engine power loss have been attributed to this condition.

1. Remove top and lower left hand engine cowl.
2. Locate alternate air valve linkage on left side of engine air box. See Sketch "A" attached.
3. Position the alternate air control (inside the cockpit) approximately mid-way between primary and alternate position.
4. Bend stop tab so that linkage is stopped 0.12 inch + 0.060/- 0.0 inch before center. Take measurement from line between the center of the bolt that is the hinge point for the cable lever and the center of the bolt that is the hinge point for the valve lever.

5. Position the alternate air control (inside cockpit) in the primary (up position). Insure that the control is in the gate that prevents it from springing downward.
6. Adjust cable housing in cable clamp so that cable pushes linkage against the stop. Tighten cable clamp.
7. Operate alternate air control (inside cockpit) between primary and alternate air position. Verify that operation is normal and that the linkage does not go over center when control is in the "primary position".
8. Reinstall lower left hand and top engine cowl.
9. Make a logbook entry of compliance with this Service Bulletin.
