Can inlet corrosion be stopped simply by washing?

Stop

by Abram Finkelstein

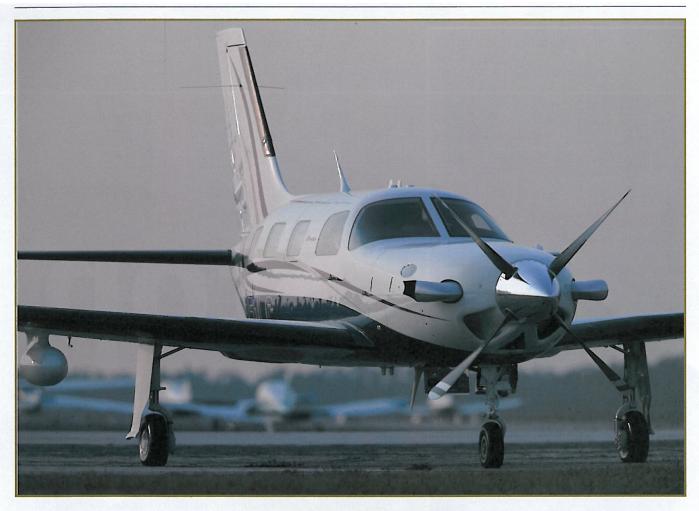
In simple terms, the problem is corrosion forming on the compressor air inlet for the PT6-42A engine of the Meridian, often under the seal at the six o'clock position. The problem has been found on aircraft of various ages. from numerous regions and with a variety of engine hours and cycles. Although neither Piper nor Pratt & Whitney Canada (PWC) have provided any statistical information on this issue, there are reports that during the past year the problem has affected more than 40 of the approximately 300 Meridians that have been manufactured. Indeed, several observers believe that this is a problem that will affect most, if not all, of the Meridian fleet in time.

According to Kevin Riecker at Sun Aviation, one of the leading maintenance facilities for the Piper Meridian and a designated Piper Service Center, perhaps three-quarters of the Meridians The majority of airplanes that have corrosion in the air inlet have it at the six-o'-clock position.

That could suggest that moisture is being trapped between the seal and the magnesium air inlet.
